# Helical Masonry Repairs – Emergency Stabilisation of Gable Wall Bleesby House Farm, North Lincolnshire

**Client:** NFU Insurance  
**Consultant:** Howard Ward Structural Engineers  
**Value:** £4,500  
**Project Duration:** 2 Days  
**Completion Date:** 2008

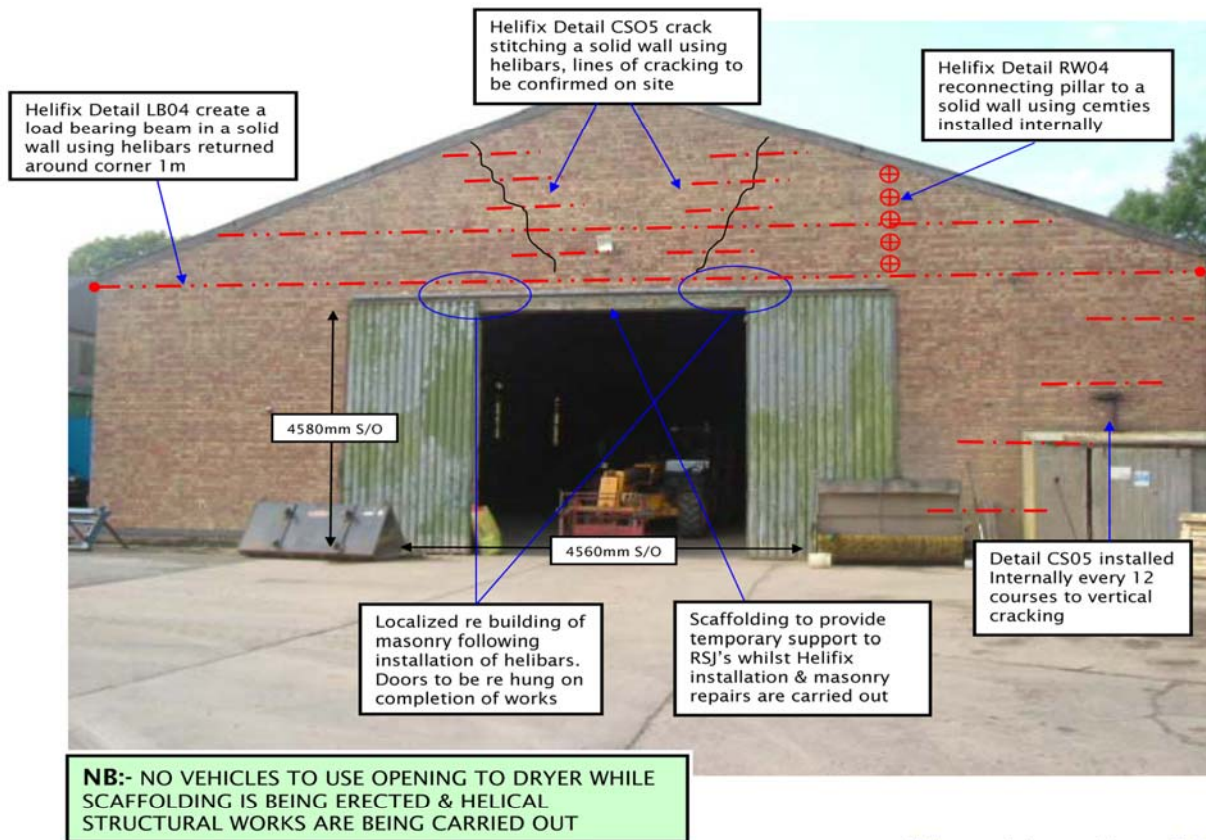
During the middle of harvest a tractor drove out of the dryer building with its trailer raised, severely damaging the gable wall of the building and making it unsafe. The consequential losses for the farms insurer was huge as the building became unusable.

The gable clearly needed re-building but a temporary repair using our Helical masonry restraint system made the gable safe. Harvest proceeded, albeit with a 48 hour delay and the gable was re-built the following springtime whilst the building was not in use.
